ExpertALERT™ automated diagnostics performance

210 TON York air conditioning chiller

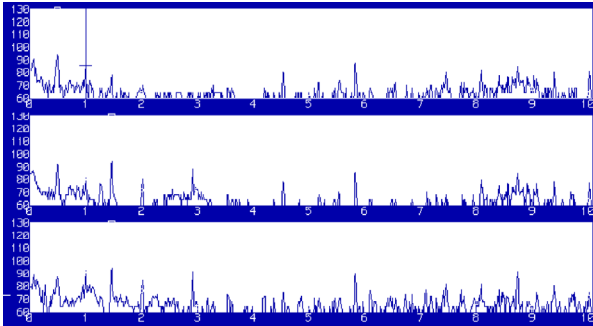
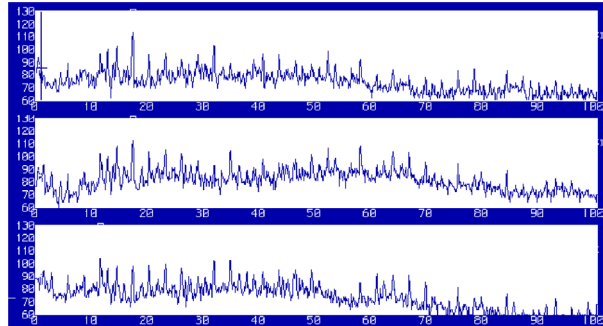
EADS reported a **SERIOUS compressor journal bearing wear problem** and cited several peaks of the compressor shaft harmonic series as the offenders (see report below). Along with determining the mechanical fault, the report also provided a recommendation to **inspect compressor bearings for proper clearances** and gave it a **"Medium"** priority grade.

Journal bearing problems are difficult to diagnose. Unlike rolling-element contact bearings, there is no clear mechanism for generating specific vibration frequencies. As the sleeve bearing wears, the clearances increase. This increase in clearances often times causes a series of harmonics in the spectrum at the running speed. Manual analysis was also performed by an SymphonyAI Industrial analyst to back up the EADS automated diagnostics, and found to be in agreement with the EADS report (see low and high range graphs below).

PRIORITY MED:  INSPECT COMPRESSOR BEARINGS FOR PROPER CLEARANCES
Maximum Level is: 114 (+ 7) VdB [3A] at 6.00xC

SERIOUS COMPRESSOR JOURNAL BEARING WEAR
is indicated by 114 VdB [3A] at 6.00xC
                 112 VdB [3R] at 6.00xC
                 105 VdB [3R] at 8.00xC
                 107 VdB [3R] at 18.00xC
                 108 VdB [3R] at 20.00xC
