ExpertALERT™ automated diagnostics performance

210 TON York air conditioning chiller

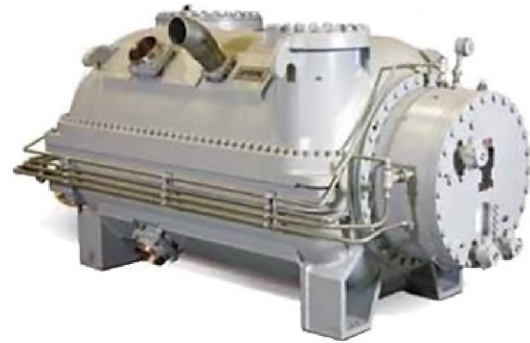
As part of a service agreement, York International was required to provide the University of Pennsylvania power plant with a vibration analysis survey on its 210 ton chiller. SymphonyAI Industrial was chosen to perform this machine condition analysis by York. The chiller unit consisted of an AC motor, running at 3570 RPM, coupled to a speed increaser gear set with 41 pinion teeth turning the centrifugal compressor shaft at approximately 10,400 RPM. The compressor had 17 compressor vanes and was fitted with journal (sleeve) bearings.
